**Flood Control Project Maintenance
Levee Inspections**

Maintenance Issue Types Only, Levee Inspection Report By Mile - Spring 2017

Reclamation District No. 0536 Egbert

Waterway	Bank	Unit Miles	Inspection Start/End	Inspector
Unit No. 01 Lindsey Slough	Right	5.58	04/11/2017 04/11/2017	Herman Phillips

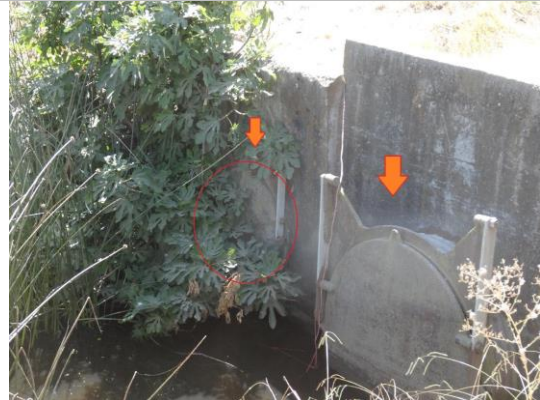
Photo 1 of 3 : UCIP_SP_2017_50161_34457.jpg

Comment Code					
Inspector Comment					
FS_ID:50161 DS_ID:22712 EP_NO: 10114 Repair Type: Urgent Crossing Status: Found UCIP Comments: 06/01/2016: Holes and heavy corrosion inside pipe on WS have gotten worse. Flapgates appear in good condition though vegetation blocks view of flapgate for 36-inch on WS. These pipes are still in use and necessary for drainage; pipes may be eligible for repair under DWR Deferred Maintenance Program. (K. Fazel - UCIP)08/13/2013:- Holes in pipe outlet due to heavy corrosion.- Needs detailed investigation of the pipe.- Headwall cracked and tilted on WS. (P. Amatya - DWR) FIELD_STRUCT_DESC: 1 of 2: 60-inch corrugated metal drainage pipe through the levee, 10 feet below the crown. Flap gate on the waterside (WS) and headwall on the WS and landside (LS). Culverts run under the road to provide drainage from agricultural fields to Lindsey Slough. RD0536 president is David Hearn at hearnd5@gmail.com. (Automatic Board Order (ABO) issued as Permit No. 10114, 1974 - Patterson) [Additional Reference(s): DWR Levee Log, 1992. USACE Sacramento O&M Manual 106, May 1953 (Station 294+49)]. FS Date: 6/1/2016

WS view: two CMPs with flap gates. Concrete headwall supports the pipes. A 36" CMP (left) and 60" CMP (right).

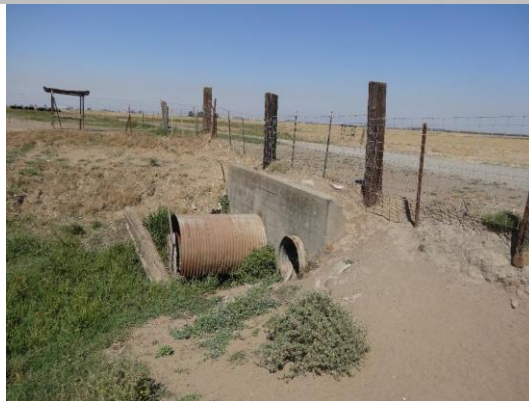
Photo 2 of 3 : UCIP_SP_2017_50161_34456.jpg

FS_ID:50161
DS_ID:22712
EP_NO: 10114
Repair Type: Urgent
Crossing Status: Found
UCIP Comments: 06/01/2016: Holes and heavy corrosion inside pipe on WS have gotten worse. Flapgates appear in good condition though vegetation blocks view of flapgate for 36-inch on WS. These pipes are still in use and necessary for drainage; pipes may be eligible for repair under DWR Deferred Maintenance Program. (K. Fazel - UCIP)08/13/2013:- Holes in pipe outlet due to heavy corrosion.- Needs detailed investigation of the pipe.- Headwall cracked and tilted on WS. (P. Amatya - DWR)
FIELD_STRUCT_DESC: 1 of 2: 60-inch corrugated metal drainage pipe through the levee, 10 feet below the crown. Flap gate on the waterside (WS) and headwall on the WS and landside (LS). Culverts run under the road to provide drainage from agricultural fields to Lindsey Slough. RD0536 president is David Hearn at hearnd5@gmail.com. (Automatic Board Order (ABO) issued as Permit No. 10114, 1974 - Patterson)

LS view: two inlet CMPs with flap gates. Concrete headwall supports the pipes. A 36" CMP (right) and 60" CMP (left).

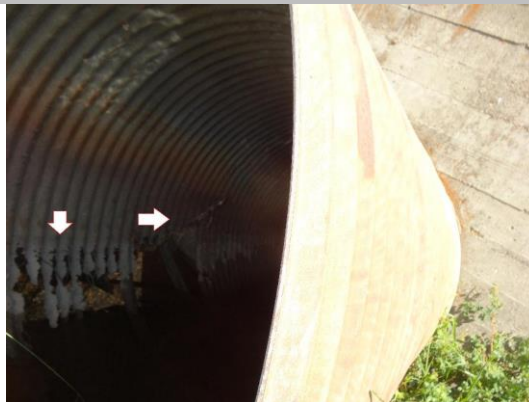
Photo 3 of 3 : UCIP_SP_2017_50161_34455.jpg

LS view: holes & cracks on CM pipe due to heavy corrosion. Needs detailed investigation of the pipe.

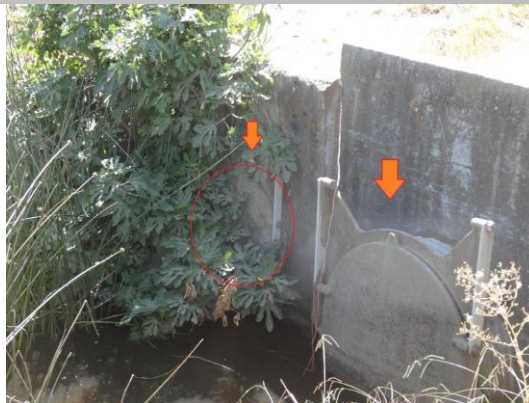
Photo 1 of 3 : UCIP_SP_2017_50160_34771.jpg

FS_ID:50160
DS_ID:22726
EP_NO: 10114
Repair Type: Urgent
Crossing Status: Found
UCIP Comments: 06/01/2016 Pipe is not abandoned. Though neglected, it is still functional and a needed system feature. Pipe is severely corroded with holes in it, which are visible on LS. Vegetation blocks view of flapgate on WS. Pipes may be eligible for repair under DWR Deferred Maintenance Program. (K. Fazel - UCIP)08/13/2013 This pipe seems to be abandoned. Headwall cracked and tilted on WS. (P. Amatya)
FIELD_STRUCT_DESC: 2 of 2: 36-inch corrugated metal drainage pipe through levee, 10 feet below the crown. Flap gate on the waterside (WS) and headwall on the WS and landside (LS). Culverts run under the road to provide drainage from agricultural fields (via LS ditch) to Lindsey Slough. RD0536 president is David Hearn at hearnd5@gmail.com. (Automatic Board Order (ABO) issued as Permit No. 10114, 1974 - Patterson). [Additional Reference(s): DWR Levee Log, 1992. USACE Sacramento O&M manual 106, May 1953 (Station 294+49)].

WS view: concrete headwall, flap gates on 36" CMP (left) and 60" CMP (right)

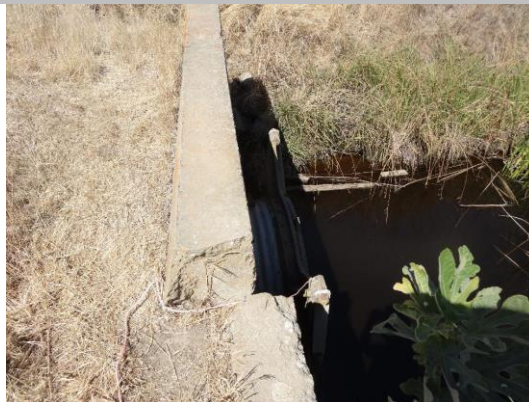
Photo 2 of 3 : UCIP_SP_2017_50160_34770.jpg

WS view: cracked and tilted concrete headwall.

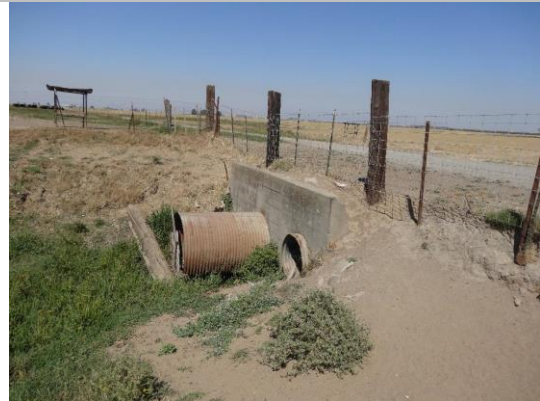
Photo 3 of 3 : UCIP_SP_2017_50160_34769.jpg

Comment Code					
Inspector Comment					
FS_ID:50160 DS_ID:22726 EP_NO: 10114 Repair Type: Urgent Crossing Status: Found UCIP Comments: 06/01/2016 Pipe is not abandoned. Though neglected, it is still functional and a needed system feature. Pipe is severely corroded with holes in it, which are visible on LS. Vegetation blocks view of flapgate on WS. Pipes may be eligible for repair under DWR Deferred Maintenance Program. (K. Fazel - UCIP)08/13/2013 This pipe seems to be abandoned. Headwall cracked and tilted on WS. (P. Amatya) FIELD_STRUCT_DESC: 2 of 2: 36-inch corrugated metal drainage pipe through levee, 10 feet below the crown. Flap gate on the waterside (WS) and headwall on the WS and landside (LS). Culverts run under the road to provide drainage from agricultural fields (via LS ditch) to Lindsey Slough. RD0536 president is David Hearn at hearnd5@gmail.com. (Automatic Board Order (ABO) issued as Permit No. 10114, 1974 - Patterson). [Additional Reference(s): DWR Levee Log, 1992. USACE Sacramento O&M manual 106, May 1953 (Station 294+49)]. FS Date: 6/1/2016

LS view: concrete headwall, 36" CMP (right) and 60" CMP (left)

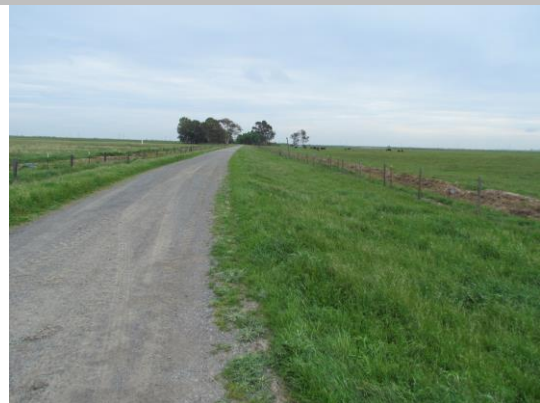
Photo 1 of 1 : SP_2017_RD0536_208_18_20170519_00045.jpg

LM Start	0.02	Rating **	M	Issue No.	18
LM End	2.90	Issue Type +	Ma	Location *	LS
Category	Earthen Levee			GPS Latitude/Longitude	
				Start	End
Item	Vegetation			38.244917 °	38.255787 °
				-121.768533 °	-121.734500 °
DWR ID	DWR_RD0536_01_s_2017_18				
Comment Code					
V1 : Control annual grass and weeds on the levee slopes and easements.					
Inspector Comment					
Control the annual grasses from the levee slope.

RD 536 Unit 1 looking downstream from levee mile 0.02.

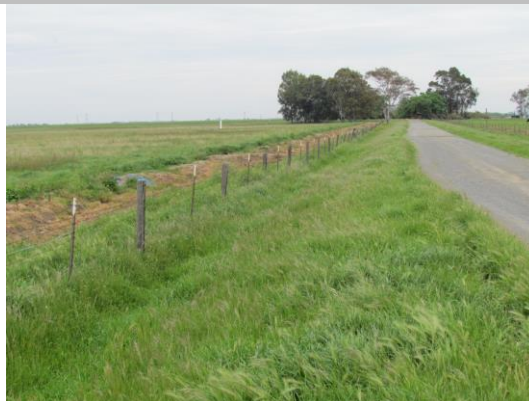
Photo 1 of 1 : SP_2017_RD0536_208_19_20170519_00046.jpg

LM Start	0.03	Rating **	M	Issue No.	19
LM End	3.28	Issue Type +	Ma	Location *	WS
Category	Earthen Levee			GPS Latitude/Longitude	
				Start	End
Item	Vegetation			38.244963 °	38.256530 °
				-121.768463 °	-121.728380 °
DWR ID	DWR_RD0536_01_s_2017_19				
Comment Code					
V1 : Control annual grass and weeds on the levee slopes and easements.					
Inspector Comment					
Control the annual grasses on the landside slope.

RD 536 Unit 1 looking downstream from levee mile 0.03.

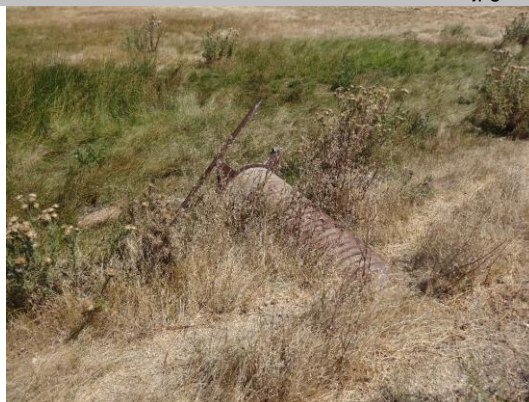
Photo 1 of 3 : UCIP_SP_2017_49313_34774.jpg

FS_ID:49313
DS_ID:22713
EP_NO: 10114
Repair Type: No Action Needed
Crossing Status: Found
UCIP Comments: 06/01/2016 Debris cleared and flapgate is no longer blocked. 08/13/2013 Outlet was blocked by concrete debris and dirt. Needs cleaning of debris.
FIELD_STRUCT_DESC: 24-inch corrugated metal drainage pipe through the levee, 10.5 feet below crown. Flap gate on the waterside (WS). This crossing is also used for irrigation. 1-inch polyvinyl chloride (PVC) pipe sleeved through 24-inch pipe visible through the landside (LS) end. According to David Hearn, district president, the PVC pipe does not connect all the way through. Present (as of 2016) landowner is Solano Land Trust and the pipe runs through the Jepson Prairie Reserve managed by University of California, Davis. [Additional Reference(s): DWR Levee Log, 1992. USACE Sacramento O&M Manual 106, May 1953 (Station 274+00)]. O&M Manual lists two headwalls with this crossing, both of which were not found in 2013 or 2016 (though concrete debris found on WS slope).

WS view: overview of exposed CM pipe on levee slope.

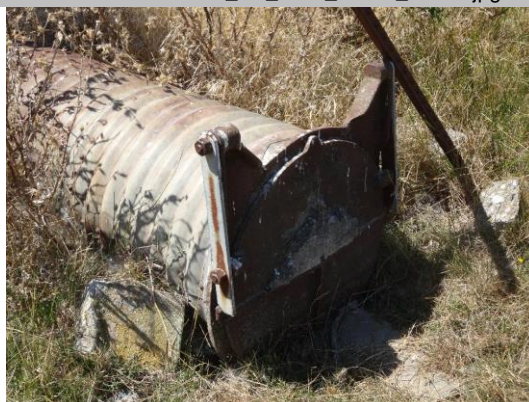
Photo 2 of 3 : UCIP_SP_2017_49313_34773.jpg

WS view: CM pipe blocked by concrete debris on levee slope.

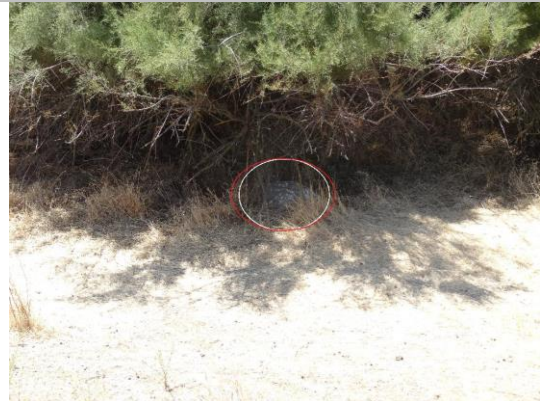
Photo 3 of 3 : UCIP_SP_2017_49313_34772.jpg

Item	DWR UCIP LMA Responsibility			38.245605 °	38.245605 °	
				-121.763441 °	-121.763441 °	
DWR ID						
Comment Code						
Inspector Comment						
FS_ID:49313 DS_ID:22713 EP_NO: 10114 Repair Type: No Action Needed Crossing Status: Found UCIP Comments: 06/01/2016 Debris cleared and flapgate is no longer blocked. 08/13/2013 Outlet was blocked by concrete debris and dirt.Needs cleaning of debris. FIELD_STRUCT_DESC: 24-inch corrugated metal drainage pipe through the levee, 10.5 feet the below crown. Flap gate on the waterside (WS). This crossing is also used for irrigation. 1-inch polyvinyl chloride (PVC) pipe sleeved through 24-inch pipe visible through the landside (LS) end. According to David Hearn, district president, the PVC pipe does not connect all the way through. Present (as of 2016) landowner is Solano Land Trust and the pipe runs through the Jepson Prairie Reserve managed by University of California, Davis. [Additional Reference(s): DWR Levee Log, 1992. USACE Sacramento O&M Manual 106, May 1953 (Station 274+00)]. O&M Manual lists two headwalls with this crossing, both of which were not found in 2013 or 2016 (though concrete debris found on WS slope). FS Date: 6/1/2016

LS view: open CM pipe end on levee slope.

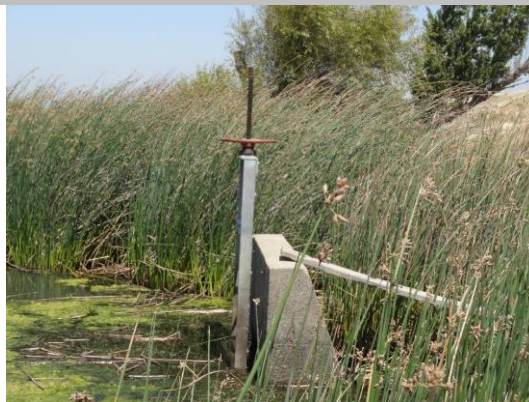
Photo 1 of 2 : UCIP_SP_2017_20444_34493.jpg

LM Start	1.10	Rating **	A/W	Issue No.	69
LM End	1.10	Issue Type +	Ma	Location *	WS
Category	Supplemental			GPS Latitude/Longitude	
				Start	End
Item	DWR UCIP LMA Responsibility			38.255412 °	38.255412 °
				-121.757605 °	-121.757605 °
DWR ID					
Comment Code					
Inspector Comment					
FS_ID:20444					
DS_ID:22715					
EP_NO: 10115					
Repair Type: No Action Needed					
Crossing Status: Found					
UCIP Comments: Pipe was submerged into water and not visible.Steel bar fence on both sides of the levee.					
FIELD_STRUCT_DESC: 42-inch corrugated metal pipe through levee 22.5 feet below crown. Screw gate on waterward end (ABO 10115, 1974). Originally included in the 1953 O&M manual, Sac 106, May 1953.					
FS Date: 8/13/2013

WS view: slide gate, concrete headwall in the channel. Pipe submerged into water.

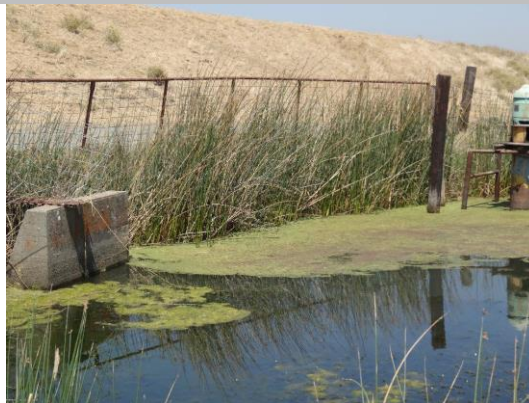
Photo 2 of 2 : UCIP_SP_2017_20444_34492.jpg

LM Start	1.10	Rating **	A/W	Issue No.	69 (cont)	
LM End	1.10	Issue Type +	Ma	Location *	WS	
Category	Supplemental			GPS Latitude/Longitude		
				Start	End	
Item	DWR UCIP LMA Responsibility			38.255412 °	38.255412 °	
				-121.757605 °	-121.757605 °	
DWR ID						
Comment Code						
Inspector Comment						
FS_ID:20444						
DS_ID:22715						
EP_NO: 10115						
Repair Type: No Action Needed						
Crossing Status: Found						
UCIP Comments: Pipe was submerged into water and not visible.Steel bar fence on both sides of the levee.						
FIELD_STRUCT_DESC: 42-inch corrugated metal pipe through levee 22.5 feet below crown. Screw gate on waterward end (ABO 10115, 1974). Originally included in the 1953 O&M manual, Sac 106, May 1953.						
FS Date: 8/13/2013

LS view: concrete headwall in the channel/irrigation ditch. Pipe submerged into water.

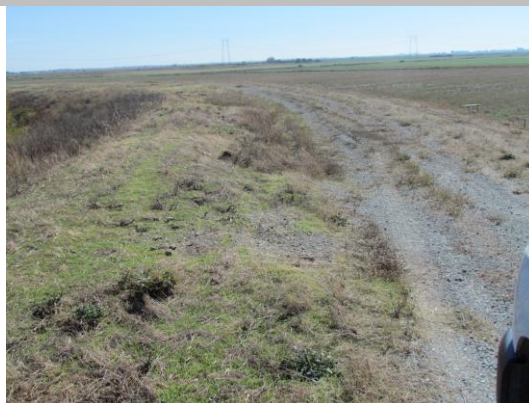
Photo 1 of 4 : SP_2017_RD0536_208_56_20170404_00009.jpg

LM Start	2.69	Rating **	U	Issue No.	56
LM End	2.71	Issue Type +	Ma	Location *	CR
Category	Earthen Levee			GPS Latitude/Longitude	
				Start	End
Item	Crown Surface / Depressions / Rutting			38.255197 °	38.254973 °
				-121.737932 °	-121.737577 °
DWR ID	DWR_RD0536_01_f_2014_56				
Comment Code					
C2 : Repair depressions or ruts in the crown or slope.					
Inspector Comment					
District need to monitor the levee crown roadway at this location. There are some issues here.

RD 536 Unit 1 looking downstream from 2.69 to levee mile 2.71.

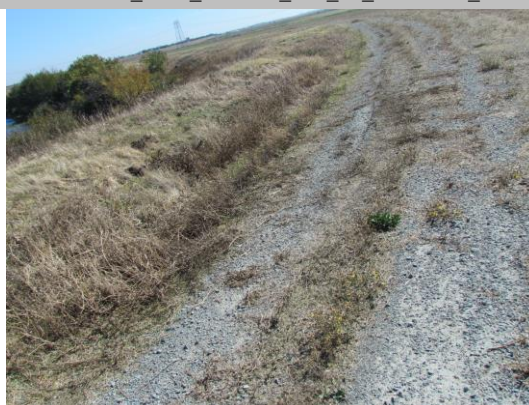
Photo 2 of 4 : SP_2017_RD0536_208_56_20170404_00010.jpg

RD 536 Unit 1 levee mile 2.69 another angle of the subsidence.

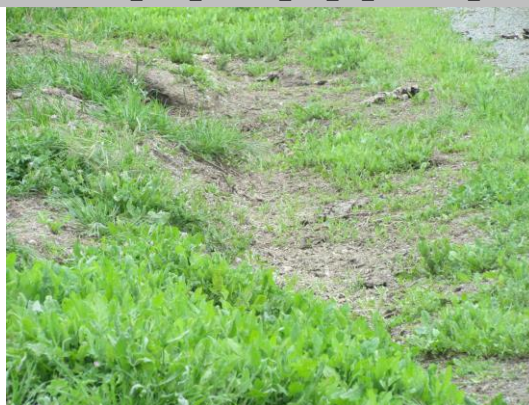
Photo 3 of 4 : SP_2017_RD0536_208_56_20170519_00048.jpg

RD 536 Unit 1 levee mile 2.69-2.71 there is a settling issue going on here at this levee site.

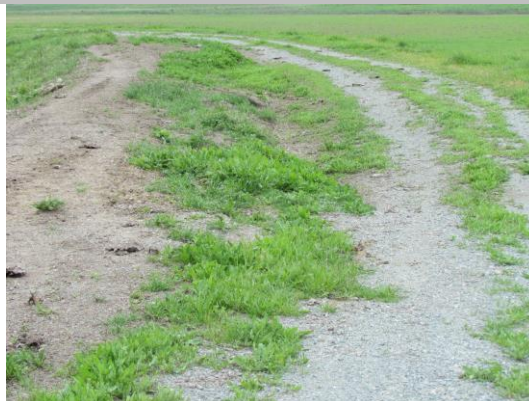
Photo 4 of 4 : SP_2017_RD0536_208_56_20170519_00047.jpg

LM Start	2.69	Rating **	U	Issue No.	56 (cont)
LM End	2.71	Issue Type +	Ma	Location *	CR
Category	Earthen Levee			GPS Latitude/Longitude	
				Start	End
Item	Crown Surface / Depressions / Rutting			38.255197 °	38.254973 °
				-121.737932 °	-121.737577 °
DWR ID	DWR_RD0536_01_f_2014_56				
Comment Code					
C2 : Repair depressions or ruts in the crown or slope.					
Inspector Comment					
District need to monitor the levee crown roadway at this location. There are some issues here.

RD 536 Unit 1 looking downstream from levee mile 2.69 to 2.71.

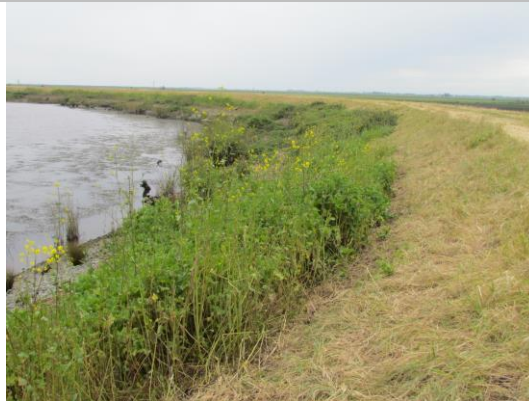
Photo 1 of 1 : SP_2017_RD0536_208_29_20170519_00050.jpg

LM Start	3.71	Rating **	U	Issue No.	29
LM End	4.37	Issue Type +	Ma	Location *	WS
Category	Earthen Levee			GPS Latitude/Longitude	
				Start	End
Item	Vegetation			38.252083 °	38.248578 °
				-121.726333 °	-121.716085 °
DWR ID	DWR_RD0536_01_s_2017_29				
Comment Code					
V2 : Remove the wild growth other than native grasses from the levee slopes.					
Inspector Comment					
Remove the tall weeds from the levee slope and toe.

RD 536 Unit 1 looking downstream from levee mile 3.71-4.37 waterside slope.

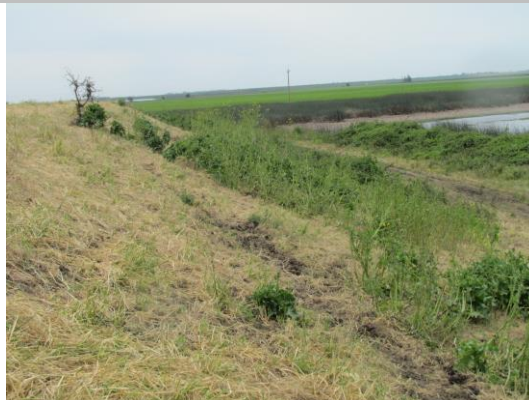
Photo 1 of 1 : SP_2017_RD0536_208_30_20170519_00049.jpg

LM Start	3.78	Rating **	U	Issue No.	30
LM End	4.70	Issue Type +	Ma	Location *	LS
Category	Earthen Levee			GPS Latitude/Longitude	
				Start	End
Item	Vegetation			38.251197 °	38.247307 °
				-121.725697 °	-121.711675 °
DWR ID	DWR_RD0536_01_s_2017_30				
Comment Code					
V2 : Remove the wild growth other than native grasses from the levee slopes.					
Inspector Comment					
Remove the wild vegetation on the landside slope.

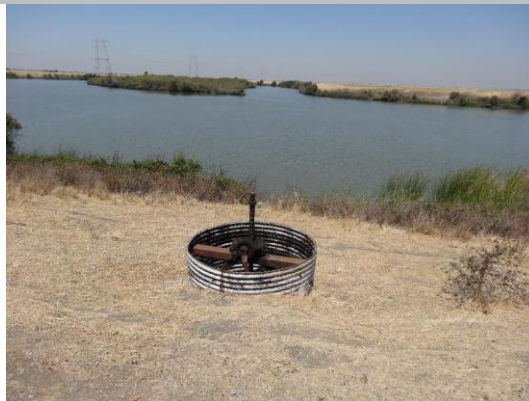
Photo 1 of 3 : UCIP_SP_2017_20503_34568.jpg

FS_ID:20503
DS_ID:22718
EP_NO: 10116
Repair Type: No Action Needed
Crossing Status: Found
UCIP Comments: Vortex seen on WS. Water flow seen on LS.Saddle, apron, and headwall not visible. Inlet and outlet pipe-ends are submerged into water.
FIELD_STRUCT_DESC: 54-inch corrugated metal drainpipe through levee 30.0 feet below crown. Screw gate in pipe riser on waterward slope (ABO 10116, 1974). Saddle, apron, headwall, 2 corrugated metal cut-off walls, 1 no. 101 gate and 1 no. 102 gate. Originally included in the 1953 O&M manual, Sac 106, May 1953.
FS Date: 8/13/2013

WS view: CMP riser with slide gate on levee slope. Water channel on background.

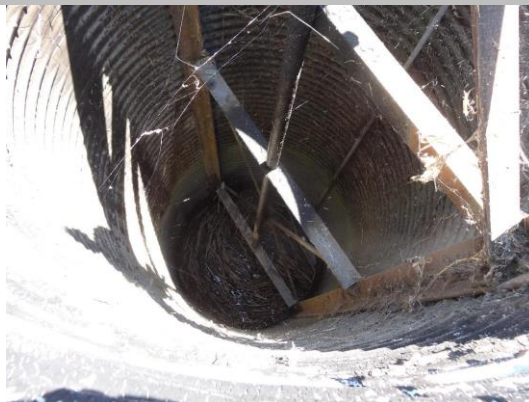
Photo 2 of 3 : UCIP_SP_2017_20503_34567.jpg

WS view: closer view of slide gate in CMP riser on levee slope.

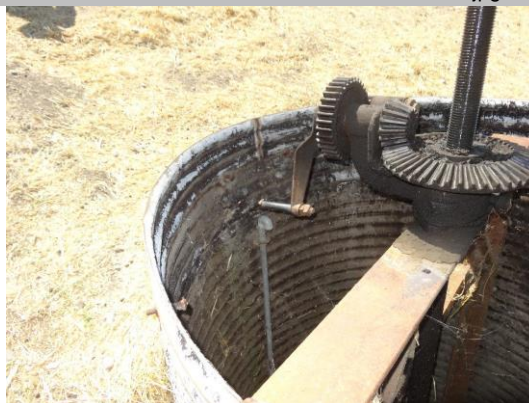
Photo 3 of 3 : UCIP_SP_2017_20503_34566.jpg

LM Start	3.92	Rating **	A/W	Issue No.	71 (cont)
LM End	3.92	Issue Type +	Ma	Location *	LS
Category	Supplemental			GPS Latitude/Longitude	
				Start	End
Item	DWR UCIP LMA Responsibility			38.250781 °	38.250781 °
				-121.723272 °	-121.723272 °
DWR ID					
Comment Code					
Inspector Comment					
FS_ID:20503 DS_ID:22718 EP_NO: 10116 Repair Type: No Action Needed Crossing Status: Found UCIP Comments: Vortex seen on WS. Water flow seen on LS.Saddle, apron, and headwall not visible. Inlet and outlet pipe-ends are submerged into water. FIELD_STRUCT_DESC: 54-inch corrugated metal drainpipe through levee 30.0 feet below crown. Screw gate in pipe riser on waterward slope (ABO 10116, 1974). Saddle, apron, headwall, 2 corrugated metal cut-off walls, 1 no. 101 gate and 1 no. 102 gate. Originally included in the 1953 O&M manual, Sac 106, May 1953. FS Date: 8/13/2013

WS view: closer view of slide gate in CMP riser on levee slope. Air vent attached to the wall of CMP (left).

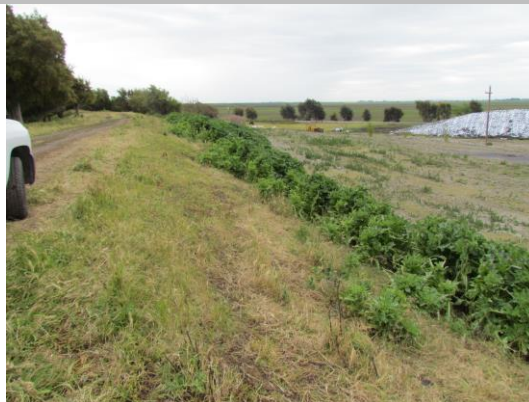
Photo 1 of 1 : SP_2017_RD0536_208_34_20170519_00051.jpg

LM Start	4.81	Rating **	U	Issue No.	34
LM End	4.96	Issue Type +	Ma	Location *	LS
Category	Earthen Levee		GPS Latitude/Longitude		
			Start	End	
Item	Vegetation		38.245970 °	38.245628 °	
			-121.710575 °	-121.708200 °	
DWR ID	DWR_RD0536_01_s _ 2017_34				
Comment Code					
V1 : Control annual grass and weeds on the levee slopes and easements.					
Inspector Comment					
Remove the wild weed growth from the landside slope and toe.

RD 536 Unit 1 levee mile 4.81-4.96 landside levee slope.

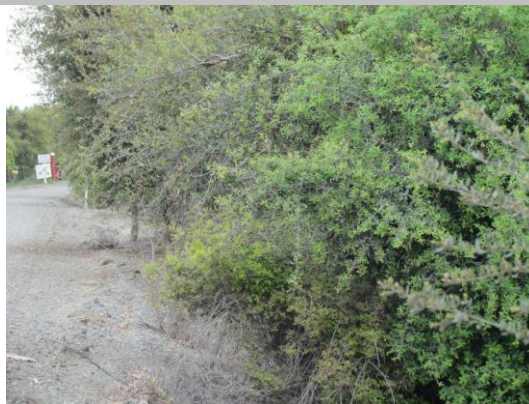
Photo 1 of 1 : SP_2017_RD0536_208_65_20170519_00053.jpg

LM Start	5.17	Rating **	U	Issue No.	65
LM End	5.39	Issue Type +	Ma	Location *	LS
Category	Earthen Levee			GPS Latitude/Longitude	
				Start	End
Item	Vegetation			38.245300 °	38.245742 °
				-121.704909 °	-121.700893 °
DWR ID	DWR_RD0536_01_s_2014_65				
Comment Code					
V7 : Trees / Woody Vegetation					
Inspector Comment					
These young oak trees need to be removed from the landward slope and shoulder before they get any larger.

RD 536 Unit 1 levee mile 5.17-5.39.

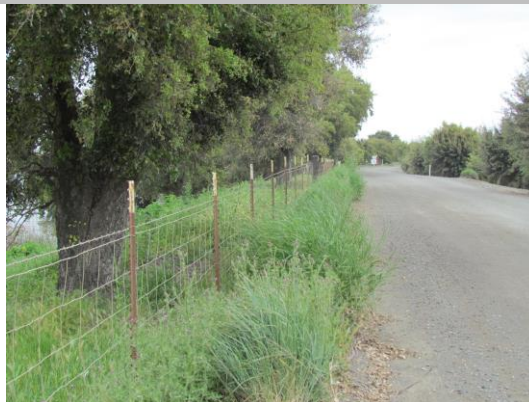
Photo 1 of 1 : SP_2017_RD0536_208_26_20170519_00052.jpg

LM Start	5.20	Rating **	U	Issue No.	26
LM End	5.57	Issue Type +	Ma	Location *	WS
Category	Earthen Levee			GPS Latitude/Longitude	
				Start	End
Item	Vegetation			38.245272 °	38.245613 °
				-121.704460 °	-121.697740 °
DWR ID	DWR_RD0536_01_f_2016_26				
Comment Code					
V1 : Control annual grass and weeds on the levee slopes and easements.					
Inspector Comment					
Control the wild grasses on the waterside levee slope.

RD 536 Unit 1 Levee mile 5.41-5.57 waterside slope and shoulder.

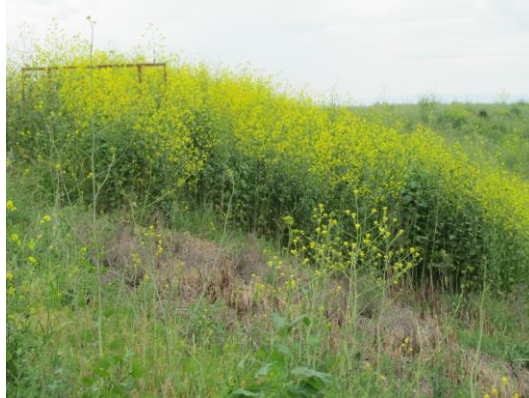
Photo 1 of 1 : SP_2017_RD0536_209_13_20170519_00015.jpg

LM Start	0.09	Rating **	U	Issue No.	13
LM End	4.99	Issue Type +	Ma	Location *	LS
Category	Earthen Levee			GPS Latitude/Longitude	
				Start	End
Item	Vegetation			38.244245 °	38.198783 °
				-121.696995 °	-121.710020 °
DWR ID	DWR_RD0536_02_s_2017_13				
Comment Code					
V1 : Control annual grass and weeds on the levee slopes and easements.					
Inspector Comment					
Remove the wild weed growth from the landside levee shoulder and slope.

RD 536 Unit 2 levee mile 0.09-4.99 Landside slope.

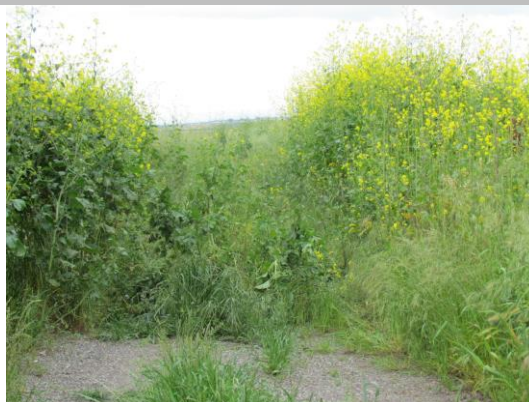
Photo 1 of 1 : SP_2017_RD0536_209_10_20170519_00018.jpg

LM Start	0.10	Rating **	U	Issue No.	10
LM End	5.01	Issue Type +	Ma	Location *	CR
Category	Earthen Levee			GPS Latitude/Longitude	
				Start	End
Item	Vegetation			38.244083 °	38.198750 °
				-121.696923 °	-121.710381 °
DWR ID	DWR_RD0536_02_s_2017_10				
Comment Code					
V9 : Keep the crown roadway free of vegetation.					
Inspector Comment					
Keep the crown roadway free of vegetation.

RD 536 Unit 2 levee mile 0.10-4.99.
